# How to rebuild a Durant and Star water pump

By Franz Fraitzl

In this article I will include the models F-M-M2-M4 and 40. The model R 50 55 and 60 have a different pump design and require separate instructions.

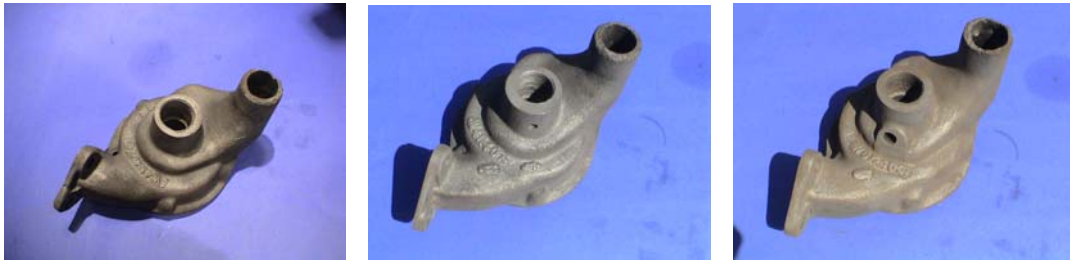
Over the years the basic design of the pumps stayed the same with small changes to the way the pumps were lubricated. The older model (W4) on the left below did not have any lubrication and the bushings and packing wore out very fast. The W4 pump in the middle shows a small hole where one could add some grease or heavy oil with a pressure oiler.

The W5 pump on the right shows a drilled and taped hole for an Almenite grease fitting or a grease pot.

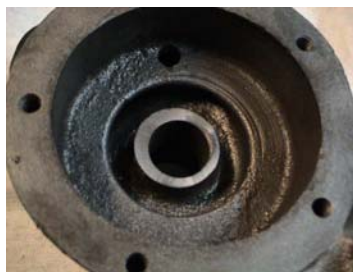
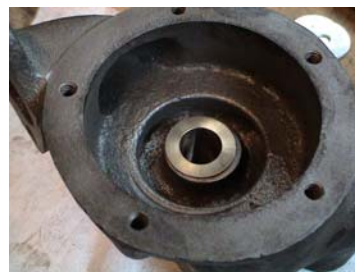
Below you can see the installation. To allow for the design, the inside of the housing has to be machined down 1/16". After removing of all the debris and cleaning of all the

threads you can install the new bushing which is made of oilite bronze.

After seeing a lot of pumps damaged on the inside I decided to change the style of the bushing. The old style is just a straight design that does not give a lot of support against wear on the edge.

The new bushing has a shoulder that is the

same diameter as the center of the impeller. This will act as a thrust washer and protect the housing and impeller from future damage.

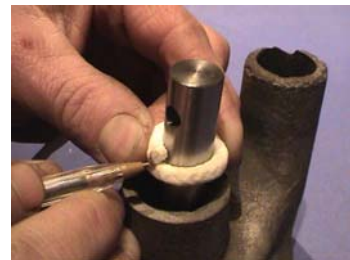
All three strips are cut they should be just less than 2" long when cut.

Push the strips in between the housing and the shaft without twisting the packing. You can purchase special tools for installing the packing or use a dental tool.

Slowly work the packing into the gap all the way down.  
Align the second strip in a 120° rotation from where the first strip butts together. Work this one down all the way and install the last strip again with a 120° rotation.

By rotating the butt joint you ensure a better seal.

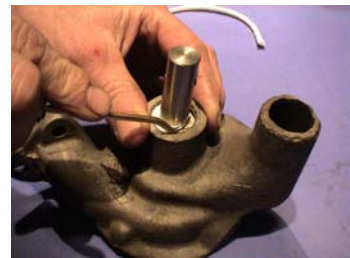
Last but not least install the packing nut and tighten it down loosely. The final tightening is done when the pump is back on the engine and running. And only tighten as much it takes to stop the water from dripping. A little drop of water here and there is better than over tighten and damaging the shaft or twisting off the rubber that connects the pump with the generator.
