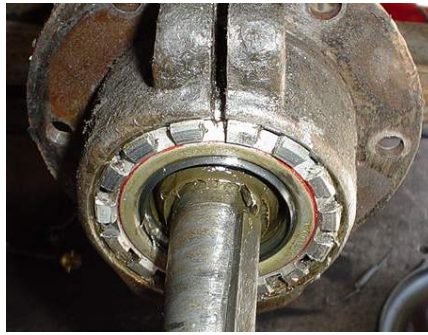
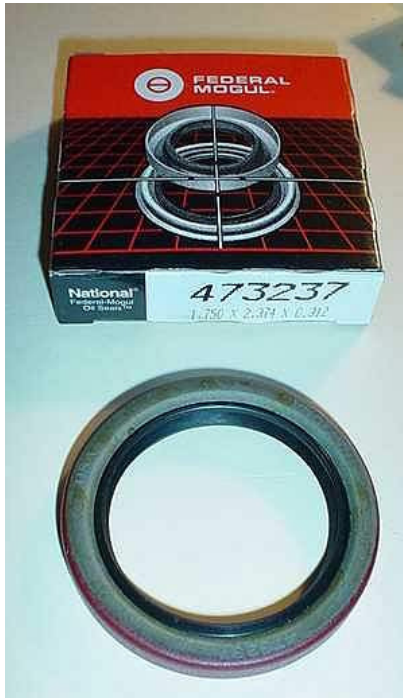
Modern seal in place (National #473237). This replaces the original grease seal that was made of Felt. Picture is from a 1929 Model 60.
